SEVENTH QUARTERLY PROGRESS REPORT
ON
PRODUCTION ENGINEERING MEASURE
FOR
TUBE TYPE 7587

DURING PERIOD OF:
1 DECEMBER 1963 TO 29 FEBRUARY 1964
CONTRACT NO. DA36-039-SC-86732
ORDER NO. 19054-PP-62-81-81

TUBE TYPE 7587

1 DECEMBER 1963 TO 29 FEBRUARY 1964

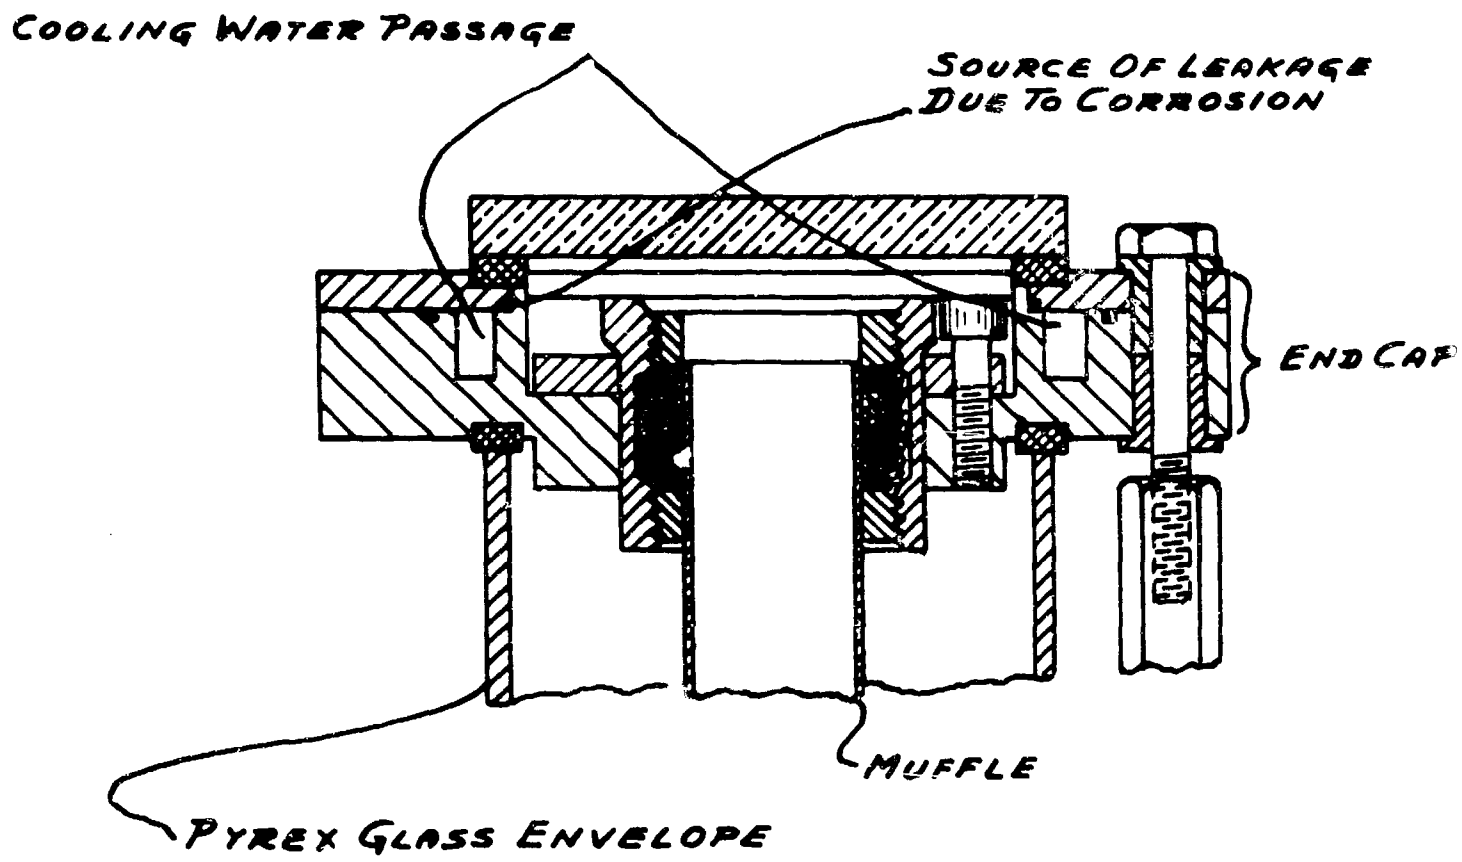
The sixteen head exhaust machine continued in full production use except for a downtime period resulting from cooling water leaks and manifold porosity. During December, the unit experienced sudden, temporary pressure rises in the high vacuum system, which occurred sporadically and very infrequently. This condition caused the manifold vacuum to drop two to three orders of pressure for several seconds during operation, and had the outward appearance of a leak that suddenly occurred, and just as suddenly disappeared. One head was removed from the machine and inspection revealed considerable corrosion in the cooling water passages of the end caps. The end caps were removed, subjected to high internal water pressure, and over a period of 24 hours, minute droplets of water appeared on the inner wall. As shown in figure 1, the end caps are a two piece structure that is copper brazed together. This construction allows the inclusion of an integral water cooling passage. By cutting a section through an end cap, it was found that corrosion had progressed along the copper brazed interface until leakage occurred. All aspects of electrolytic corrosive action were studied, but none could account for such rapid progress. However, an analysis of the recirculating cooling system water revealed a high incidence of arsenic

compounds, which was further traced to disassociation of a rust inhibitor additive. As a result, the entire cooling system for the Nuvistor plant was drained, flushed, and refilled with pure glycol. All heads were removed from the machine, and the end caps were replaced with new units.

FIG. 1
**CROSS SECTIONAL VIEW OF A TYPICAL END CAP
FOR THE EXHAUST MACHINE**
